**IEPA – DIVISION OF WATER POLLUTION CONTROL
DIGITAL PHOTO REPORT**

Date: 4-19-12	Site Name: Hunter Haven
Photo By: Lee Heeren	 
County: Carroll	
Comments: A view of the offices and milking parlor at the dairy. The digester is visible to the left, and a freestall barn is visible to the right. The view is south.	
Photo #: 1	
Photo Title: 041912_HunterHaven_LH(40)

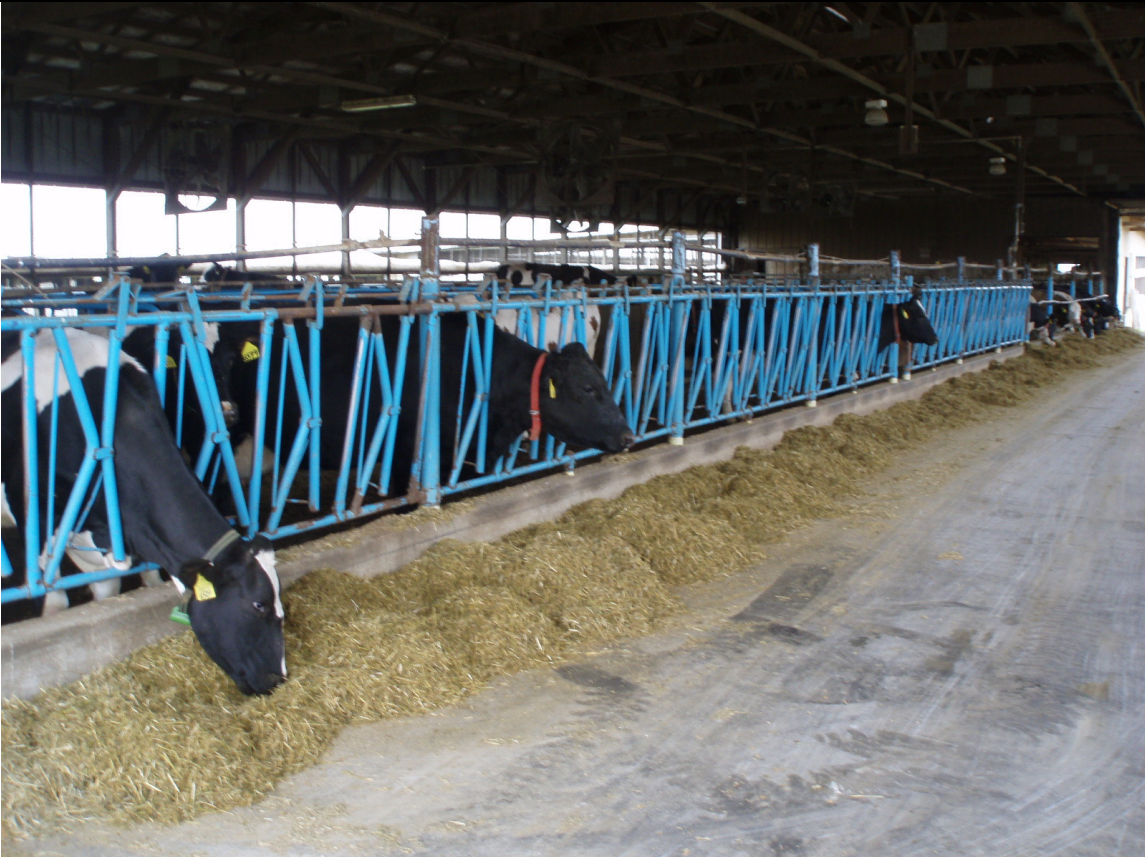
County: Carroll	
Comments: A view of the interior of the pre-fresh barn. The view is north.	
Photo #: 3	
Photo Title: 041912_HunterHaven_LH(19)

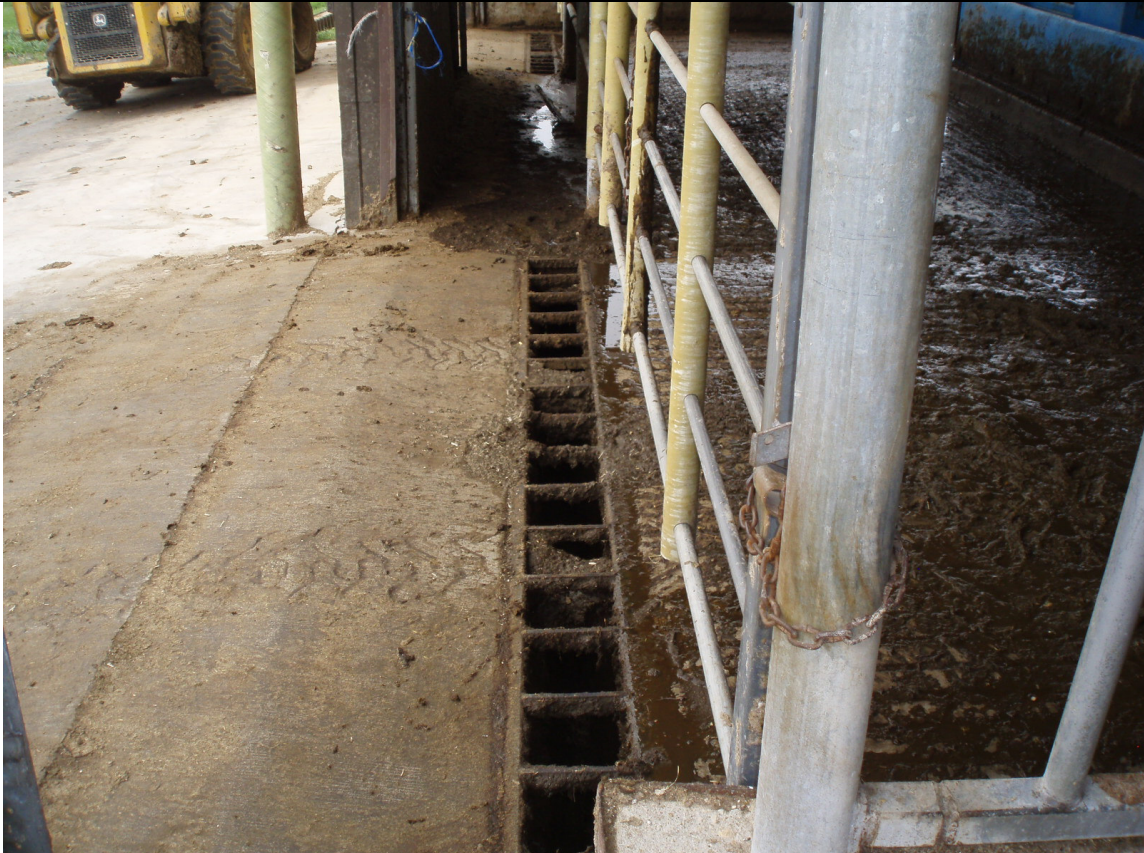
County: Carroll	
Comments: A view of one of the alley troughs at the end of a freestall barn. Waste is manually scraped to the trough and then flushed to the reception pit.	
Photo #: 5	
Photo Title: 041912_HunterHaven_LH(23)

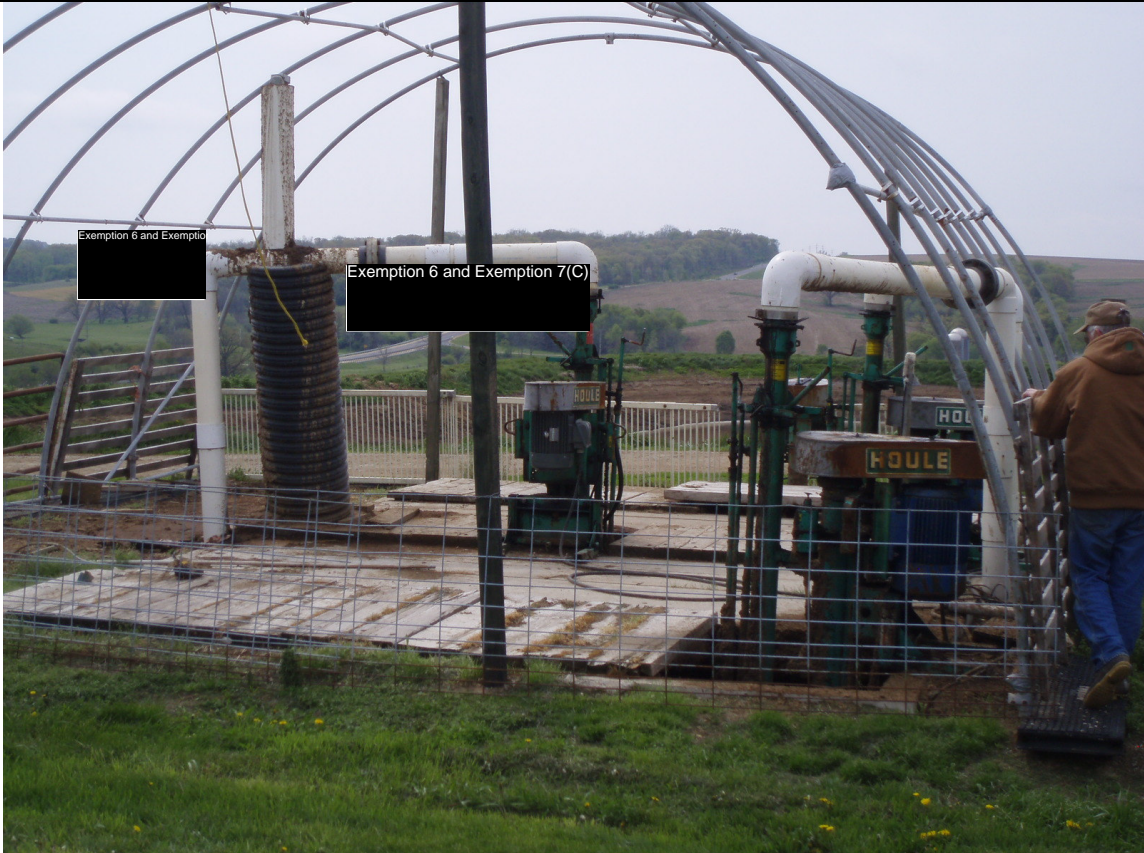
County: Carroll	
Comments: Another view of the reception pit. Flume pumps are to the right. A mixer is partially visible in the background. The pump at the left discharges waste to the digester. The pit will overflow to the waste lagoon in the background if the pump fails. The view is south.	
Photo #: 7	
Photo Title: 041912_HunterHaven_LH(5)

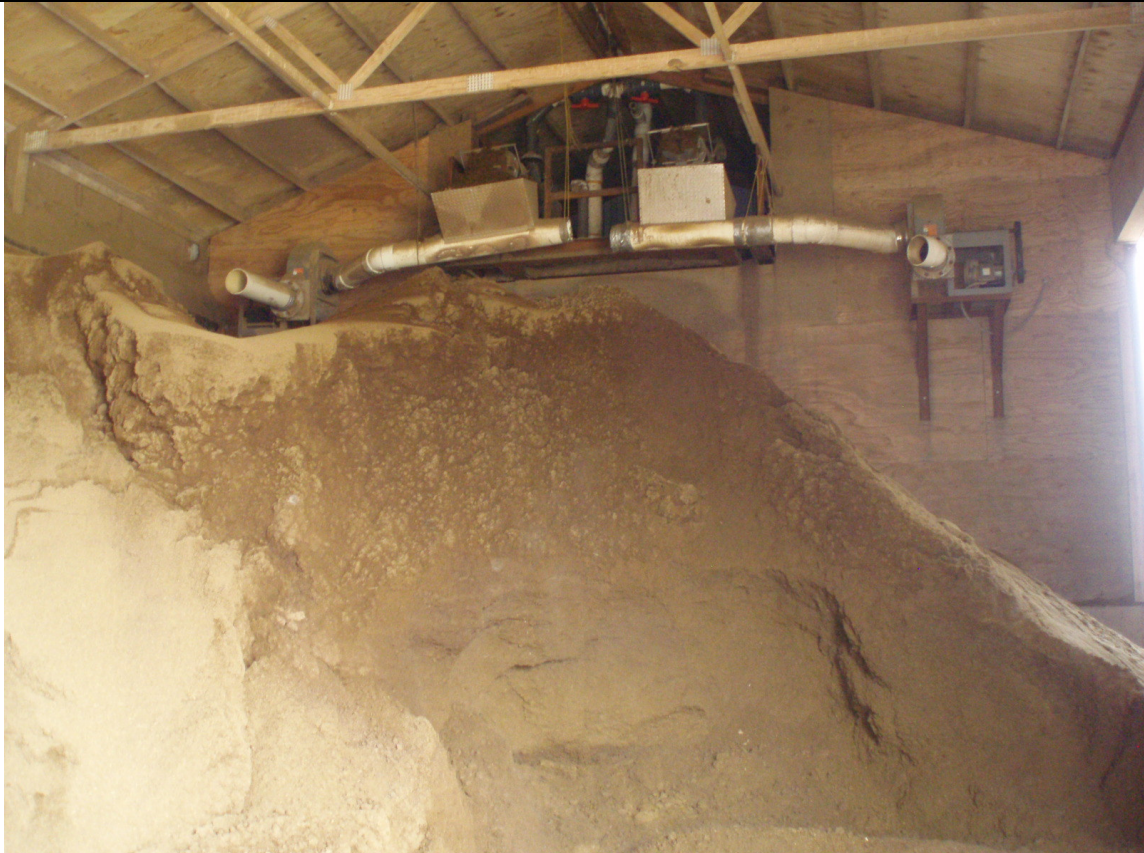
County: Carroll	
Comments: A view of the discharge from the solids separator through the dryers to the solids storage area. Material from this stockpile is used for bedding material.	
Photo #: 9	
Photo Title: 041912_HunterHaven_LH(14)

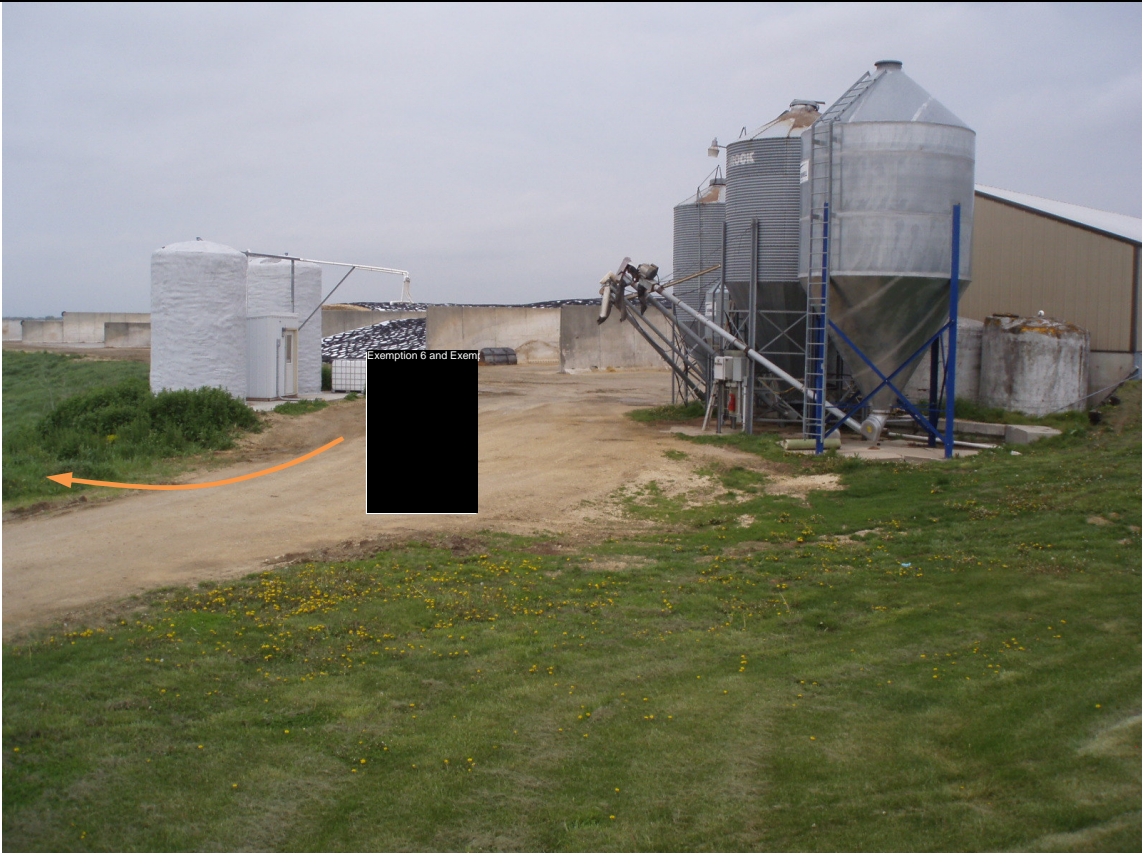
County: Carroll	
Comments: A view of the feed storage area. The bulk bins and commodity shed are visible at the right. Whey permeate obtained from a cheese plant is stored in the tanks at left. Runoff from this area flows to a grass waterway to the left. Bunker silos are in the background. Kirk Bergstrom and Doug Block are pictured. The view is northwest.	
Photo #: 15	
Photo Title: 041912_HunterHaven_LH(28)

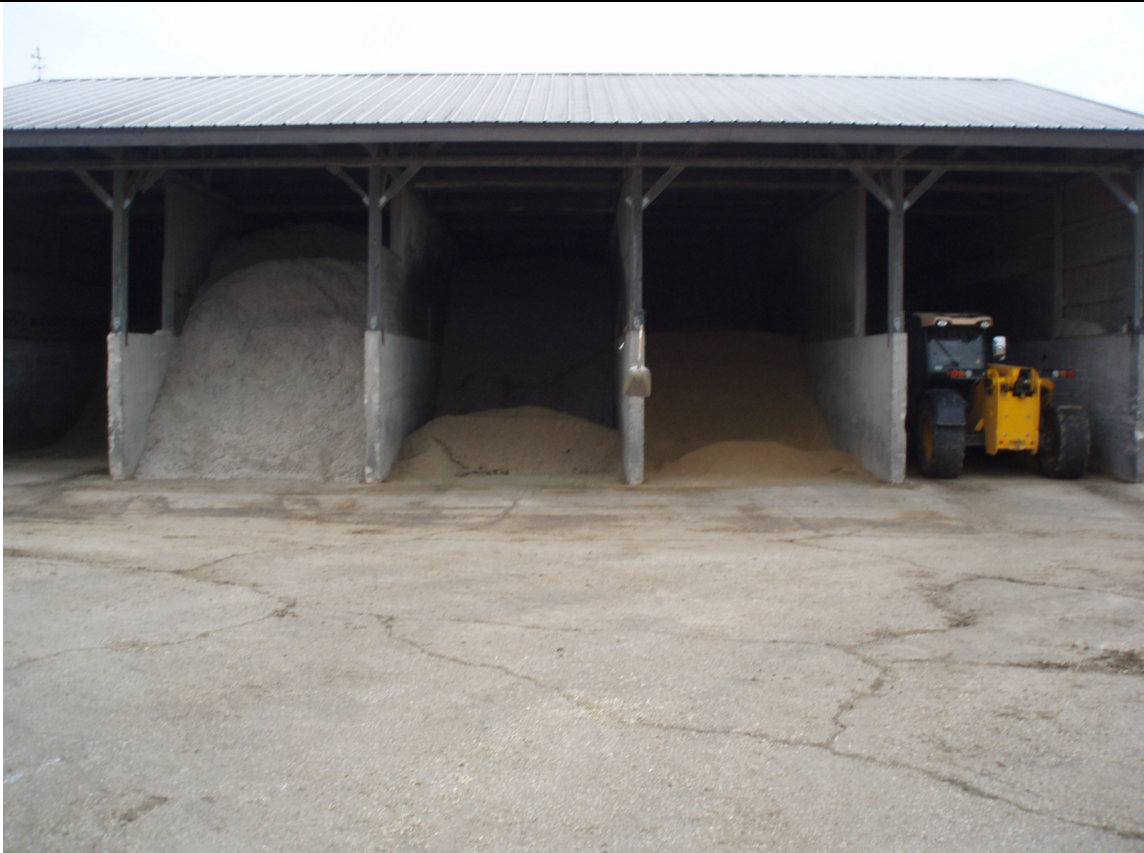
County: Carroll	
Comments: A view of the covered commodity shed. The view is east.	
Photo #: 17	
Photo Title: 041912_HunterHaven_LH(30)

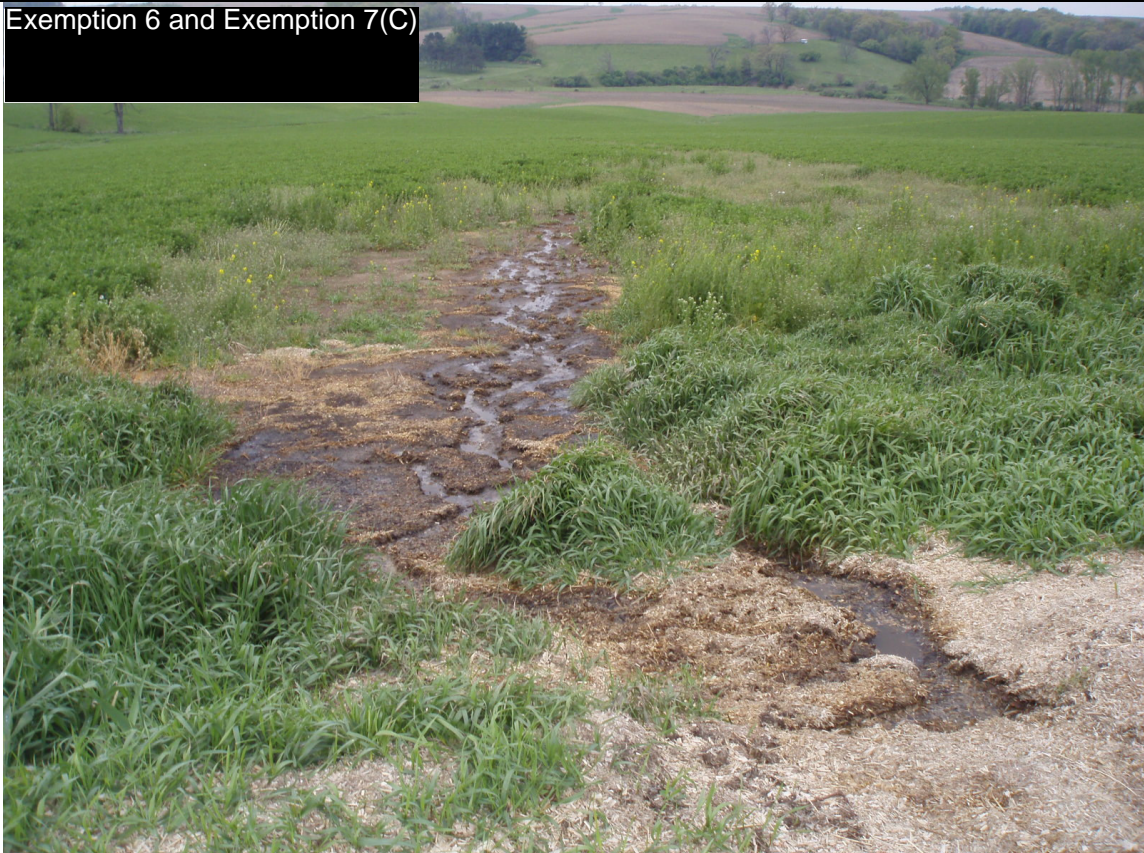
County: Carroll	
Comments: A view of the discharge path from the bunker silos. Waste feed is visible in the foreground. This vegetated area leads to a cropfield. The East Fork Creek is in the valley approximately 2000 feet south of the facility. <small>Exemption 6 and Exemption 7(C)</small>

(calves and heifers) is visible at the upper left. The view is south.	
Photo #: 19	
Photo Title: 041912_HunterHaven_LH(37)

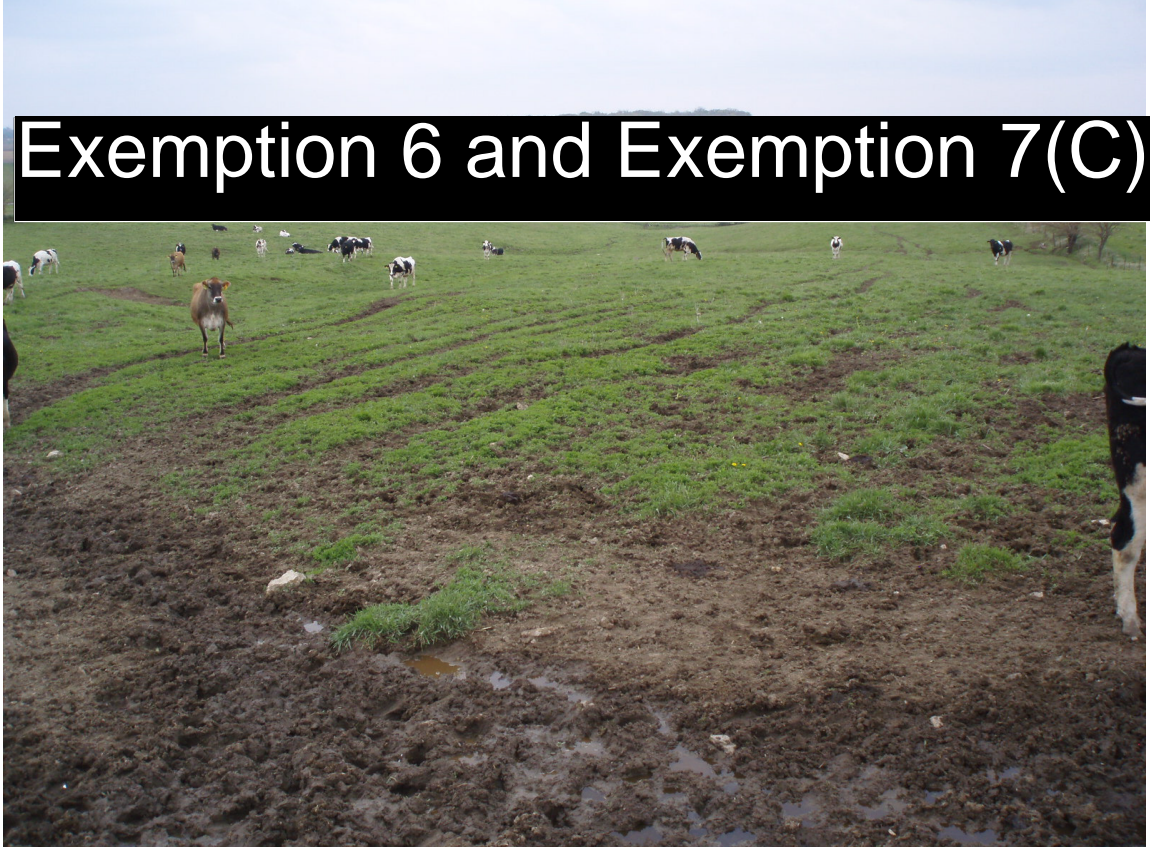
County: Carroll	
Comments: A view of the dry cow pasture looking south from the manure storage structure in Photo 21. Ill. Rte 73 is visible at the left. The East Fork Creek is located near

farm visible at the upper right, 2400 ft from this site.	
Photo#: 22	
Photo Title: 041912_HunterHaven_LH(44)

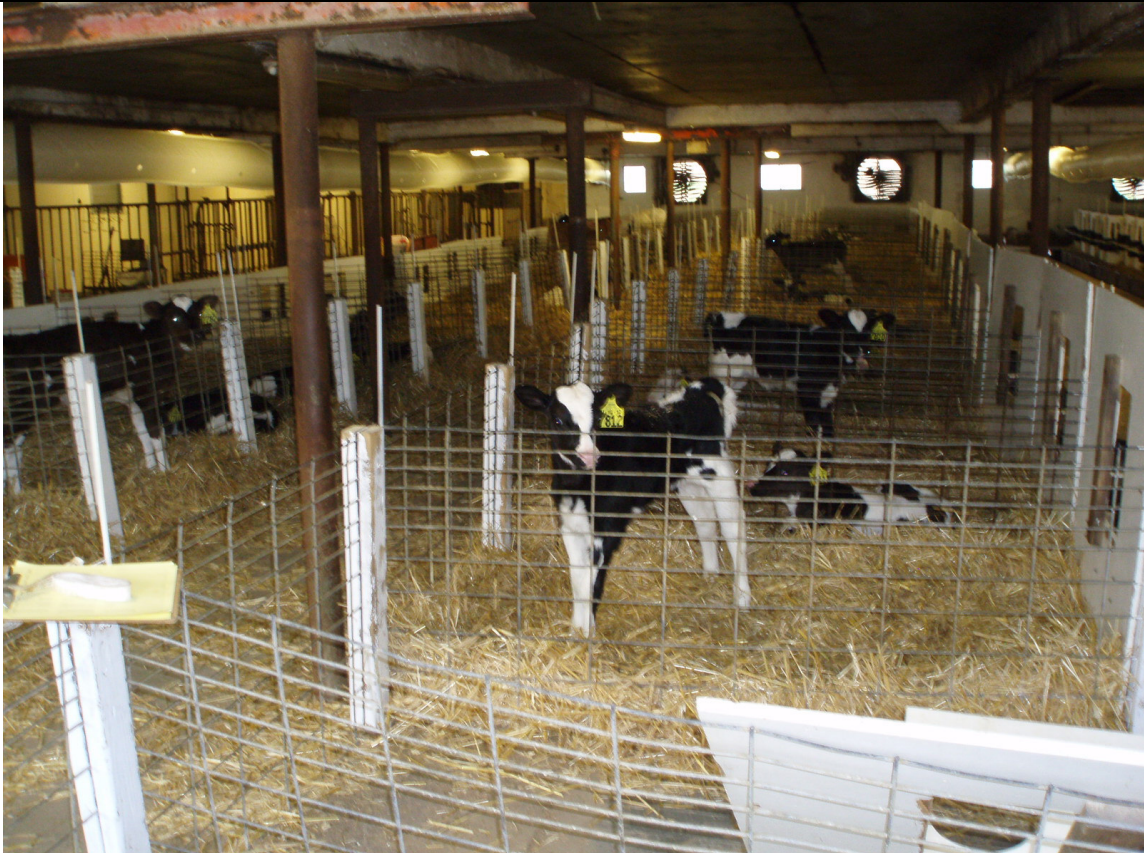
County: Carroll	
Comments: A view of the interior of the calf barn exemption is an	
farm. The calves are housed in the old dairy barn. A barn cleaner moves manure and bedding to the wastewater detention pond north of the barn.	
Photo #: 23	
Photo Title: 041912_HunterHaven_LH(45)

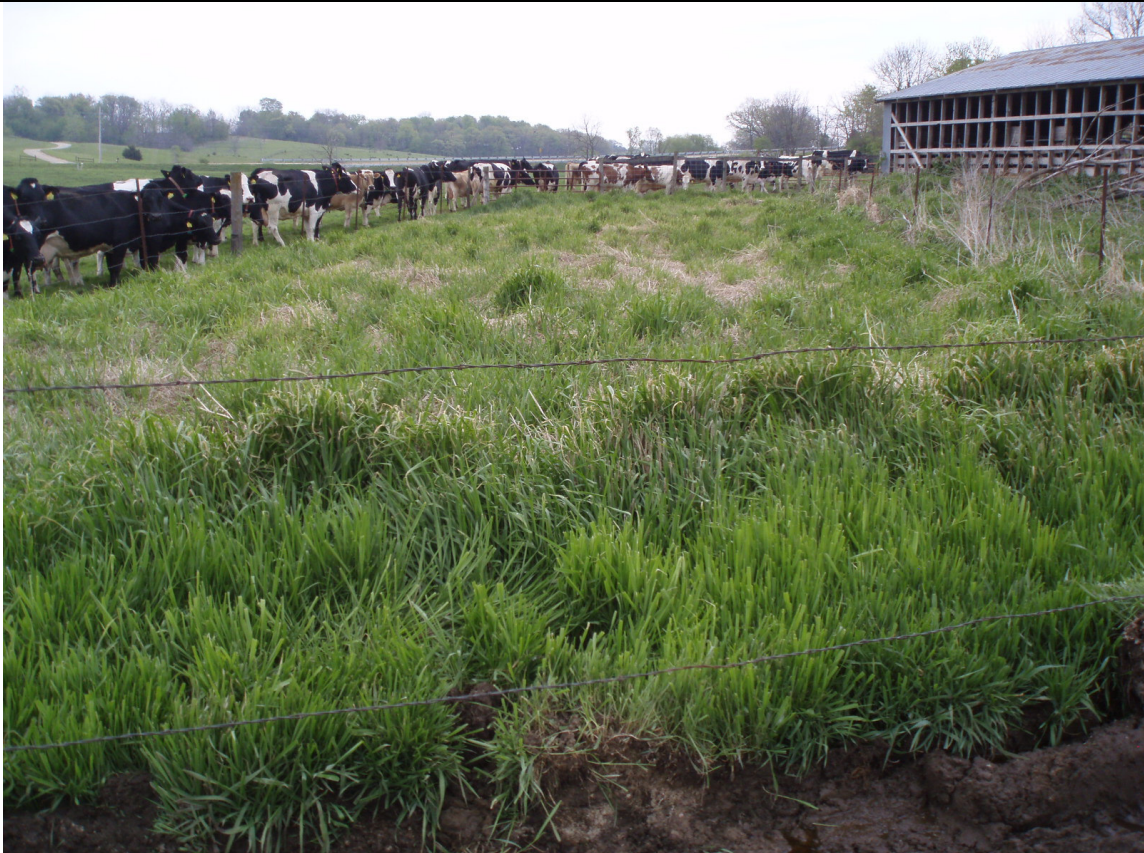
County: Carroll	
Comments: A view looking "uphill" into the filter to the left of the previous photo. The view is southeast with a heifer shed at the right.	
Photo #: 29 Photo Title: 041912_HunterHaven_LH(56)

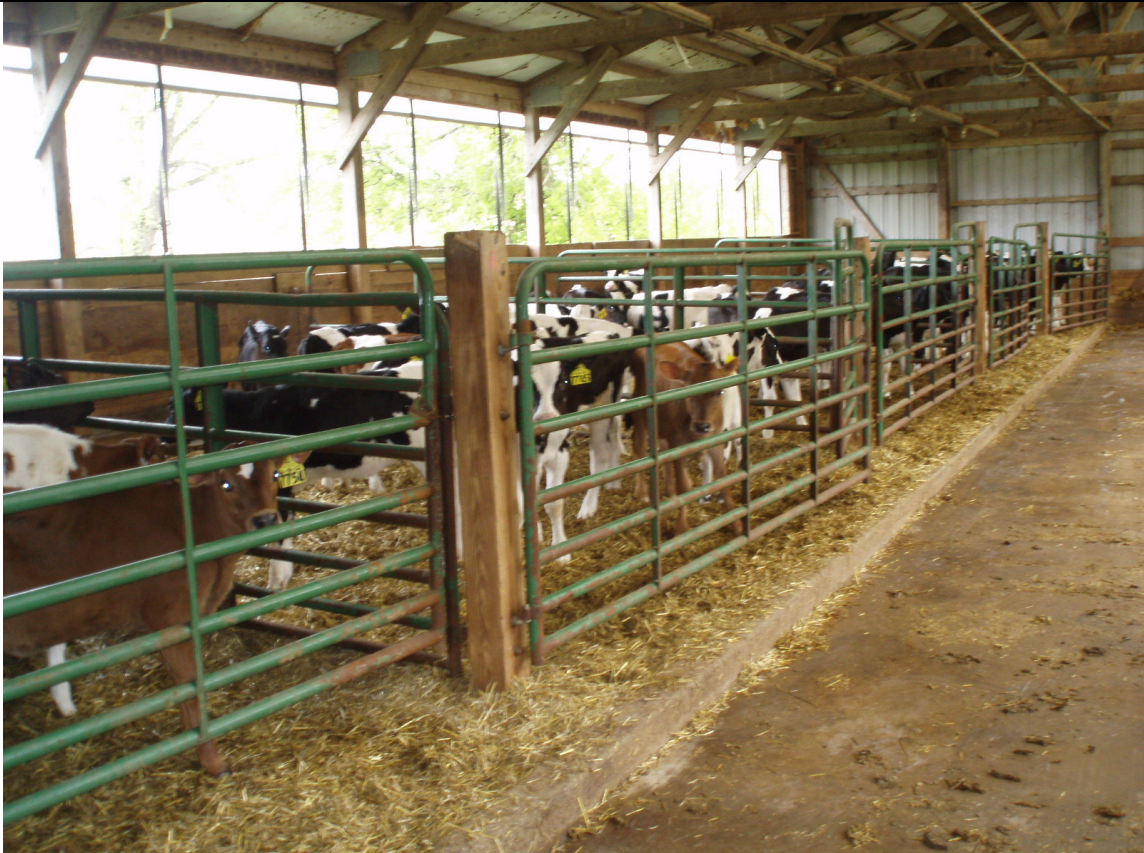
County: Carroll	
Comments: A view of the interior of a calf barn at the West Lott Road farm.	
Photo #: 33	
Photo Title: 041912_HunterHaven_LH(58)

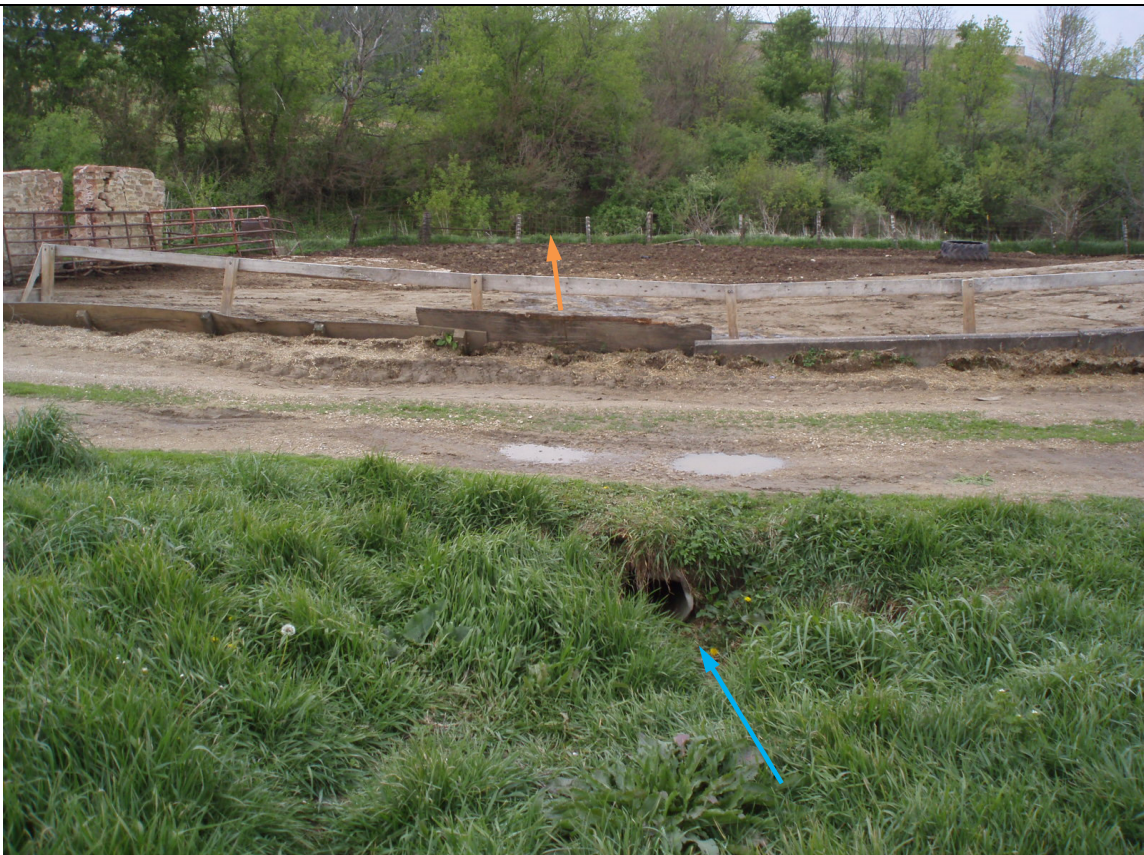
County: Carroll	
Comments: Another view of the feedlot for the summer pasture. Runoff from cropfields uphill flows through the culvert in the center of the photo, under the feedbunks, and then across the feedlot to the unnamed tributary located 60 feet past the fence. The view is south.	
Photo#: 38	
Photo Title: 041912_HunterHaven_LH(70)
